Lithonia Lighting CFMK Surface Mount Brackets recalled due to Injury Hazard

<h2>Affected Products</h2>		
Lithonia Lighting CFMK Surface Mount Brackets		
<h2>Product Description</h2>		
<p>This recall involves metal CFMK H-brackets that are screwed into the ceiling and used to surface mount CPANL LED fixtures. The CFMK bracket was included as an optional mounting accessory with 1x4, 2x4 and 2x2 CPANLs.</p>		
The following CFMK brackets are included in the recall:		
Model Number	Serial Number	Date Code
CPANL 2X2 35K with Bracket	*264JGP	L04xx18-L10xx18 GP07xx18- GP05xx20

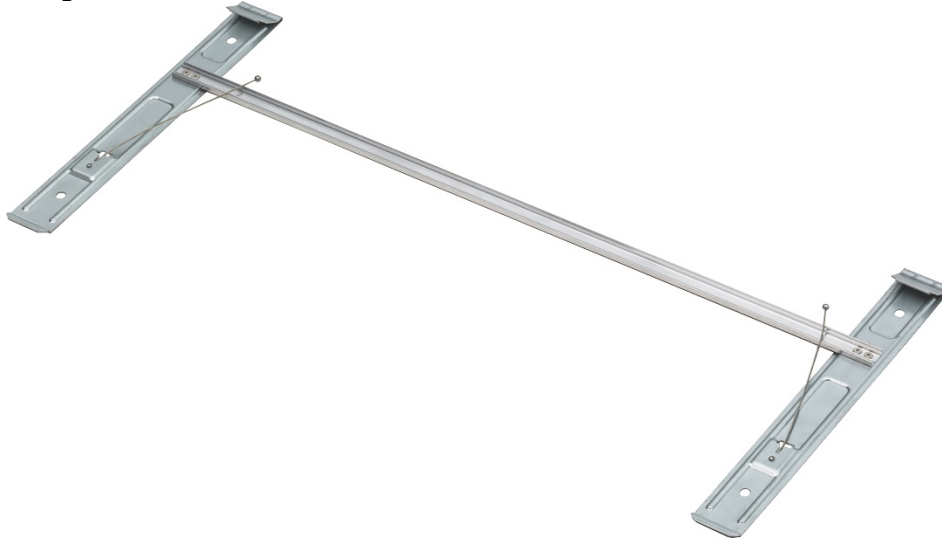
Image 1. 1x4 CFMK Bracket

The CFMK bracket can fail to securely surface mount the CPANL LED fixture and allow the fixture to fall unexpectedly, posing a risk of injury.

Consumers should immediately stop using the recalled product and contact Lithonia Lighting for a repair kit and installation instructions. Consumers should prevent people from going into the immediate area under the fixtures until the brackets are repaired.
